Historic Sites Reconnaissance of the Oak Ridge Reservation Oak Ridge, Tennessee

HISTORIC SITES RECONNAISSANCE OF
THE OAK RIDGE RESERVATION
OAK RIDGE, TENNESSEE

Department of Anthropology
University of Tennessee
Knoxville, Tennessee
August 1976

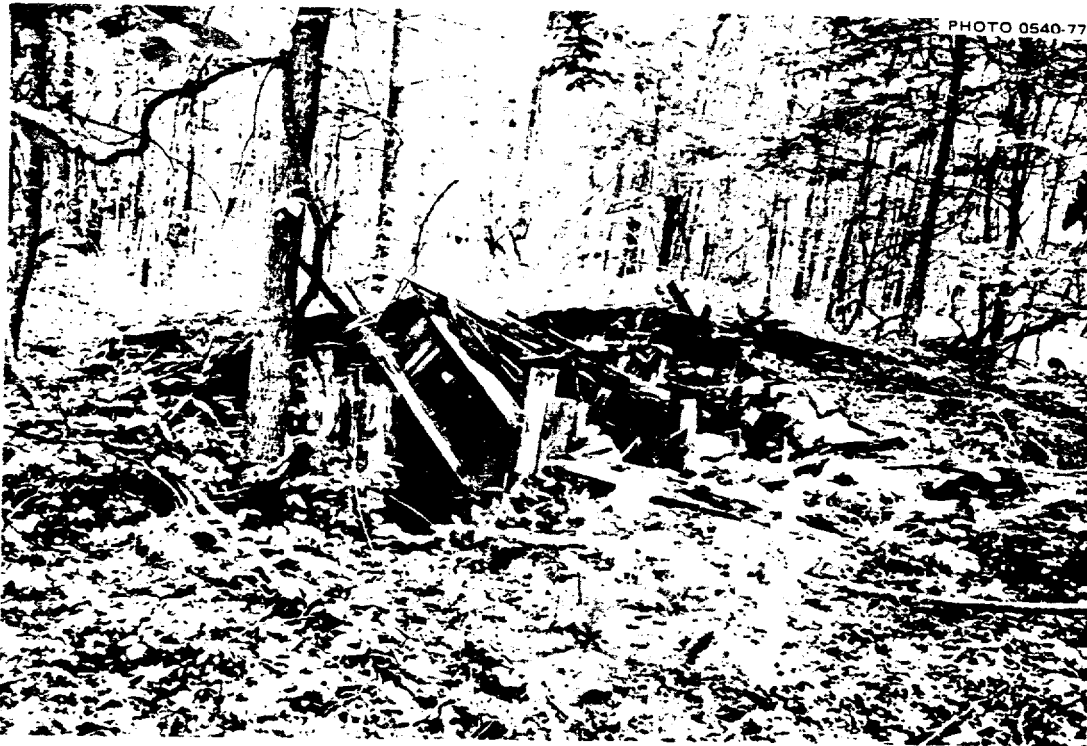
Category 2 includes building or structure sites where the fabric of the building (e.g. walls, roof, and other structural elements) has been removed from the site and only the foundation materials remain (Fig. 3). This category includes sites where only the scattered foundation piers or stone rubble from foundations and piers are observable on the surface.

Fig. 3. Example of Condition Category 2--Foundation Only.

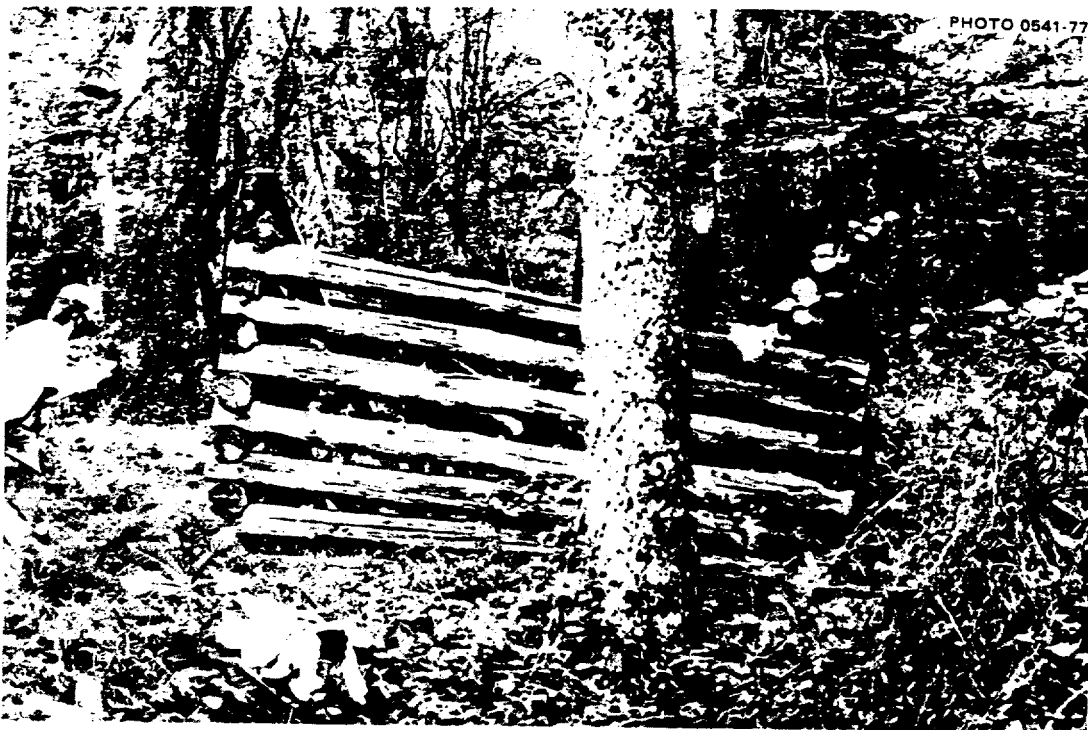
Category 3 includes sites where the building fabric is incomplete. Examples include structures for which one or two of the walls are in their original location but the roof, other walls, etc., are missing or deteriorated (Fig. 4). A structure in which the walls are standing and only the roof has been removed would be classed as belonging to Category 4.

Fig. 4. Example of Condition Category 3--Partially Standing.

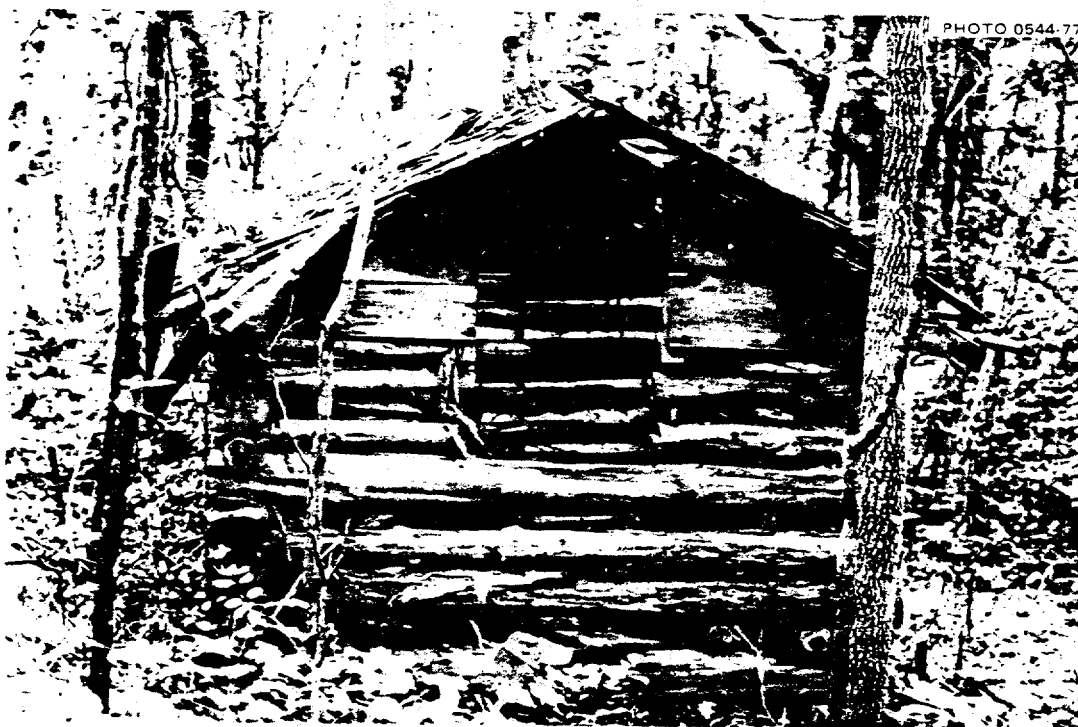
Structure 643B is a good example of a round-log-constructed crib. The walls and roof are intact (Fig. 10).

Fig. 10. Crib Constructed from Round Logs (Structure 643B).

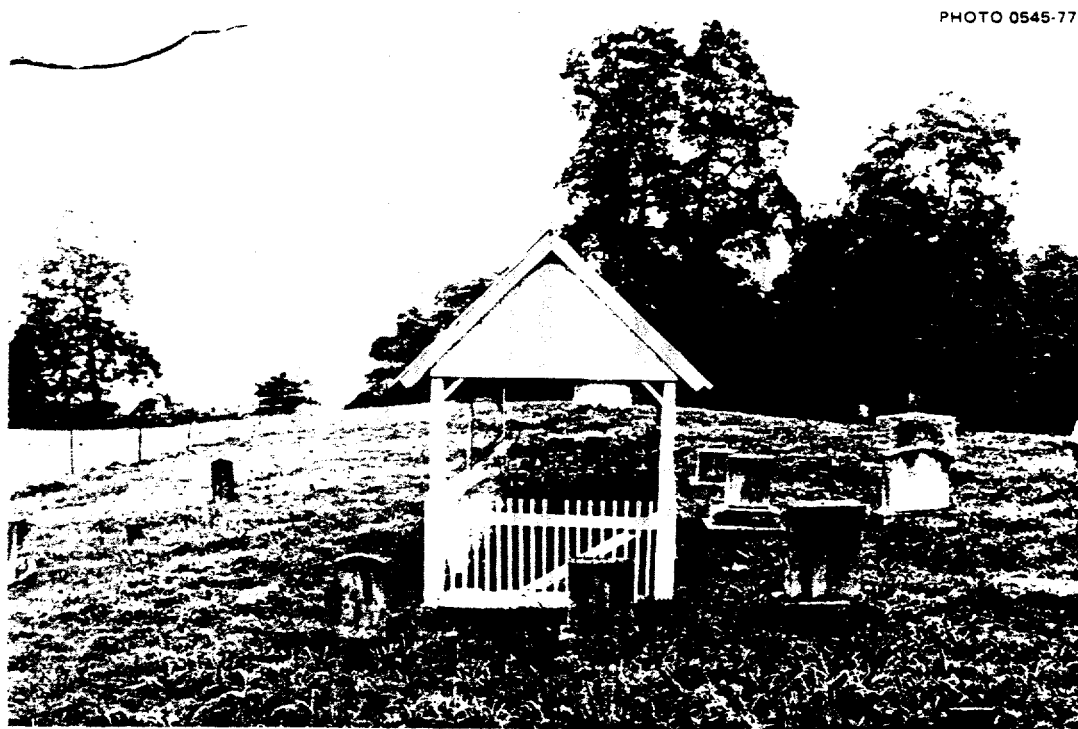
Structures 16B and 16C. These two structures, quite unusual and very distinctive, are built over and enclosing marked graves in the New Bethel cemetery. The construction technique employed is frame with picket fence walls surrounding the grave (Fig. 11).

Fig. 11. Grave House in New Bethel Cemetery (Structure 16B).

These two structures should be preserved in their present condition and maintained periodically. Their significance lies in their traditional form and as preserved examples of a kind of structure no longer found in contemporary cemeteries and memorial gardens.

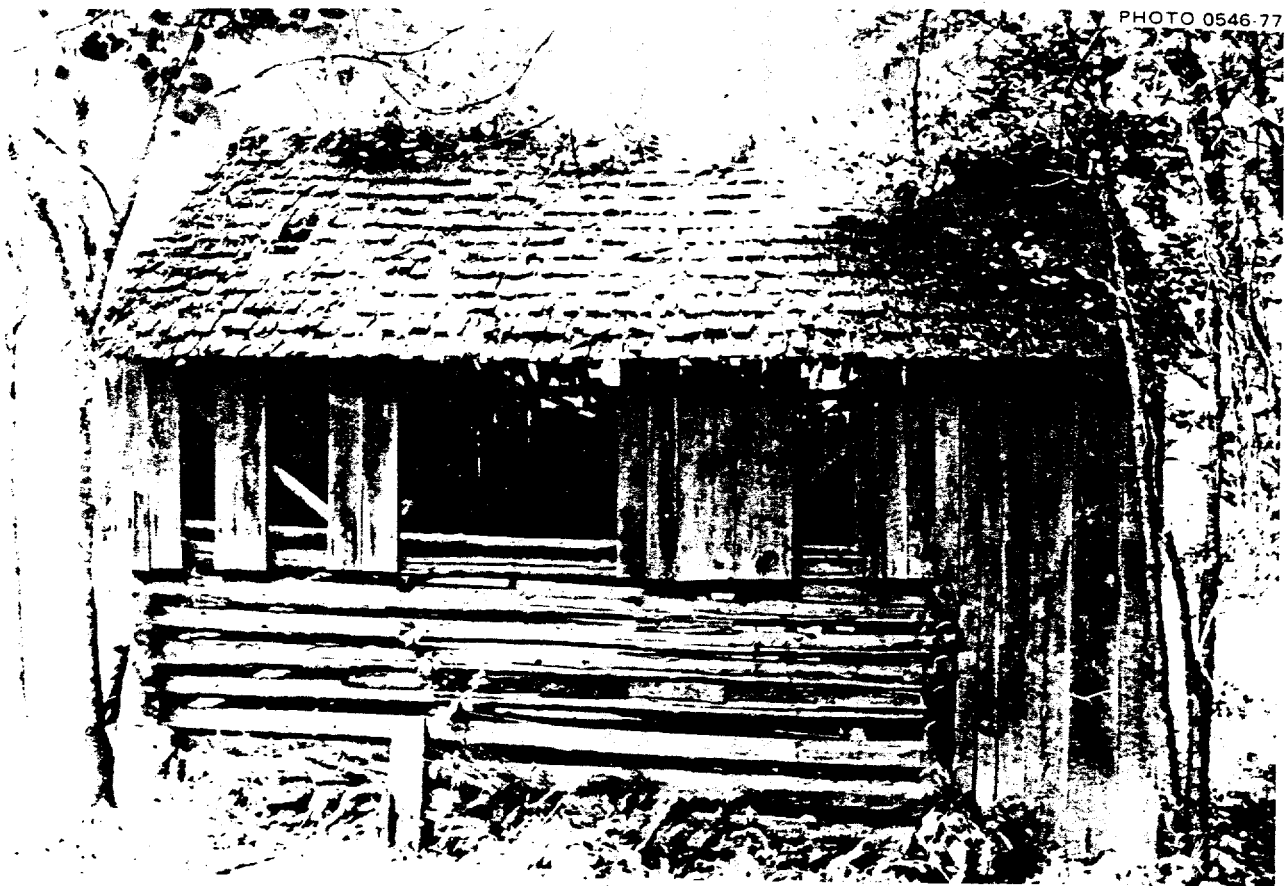
Structure 39C. This structure is a small one-crib log barn with shake roof in good condition (Fig. 12). Based on the log sizes, corner-notching technique, and general appearance, this building was probably built in the twentieth century. It does, however, represent a traditional form and construction method and should be preserved through maintenance and periodic monitoring the condition. Should the building be threatened by construction or other potentially destructive activities, it should be described in detail and possibly relocated to more favorable surroundings.

Fig. 12. Structure 39C, Single Crib Barn with Shake Roof.

It does not appear to meet the criteria for nomination to the National Register.

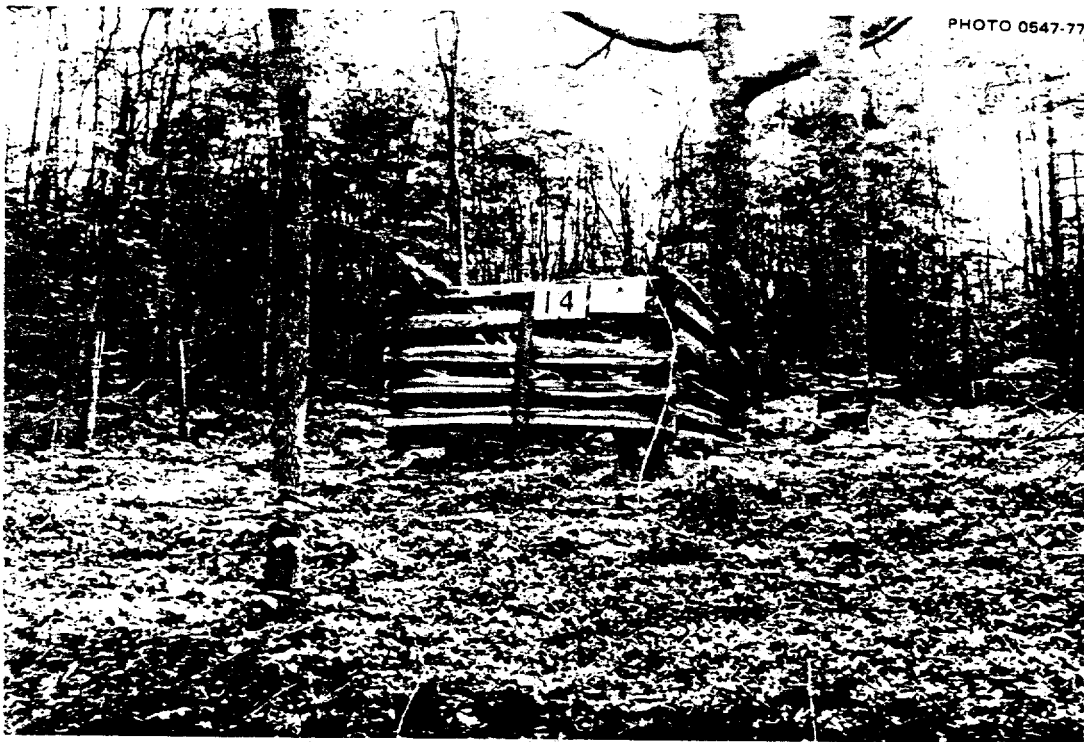
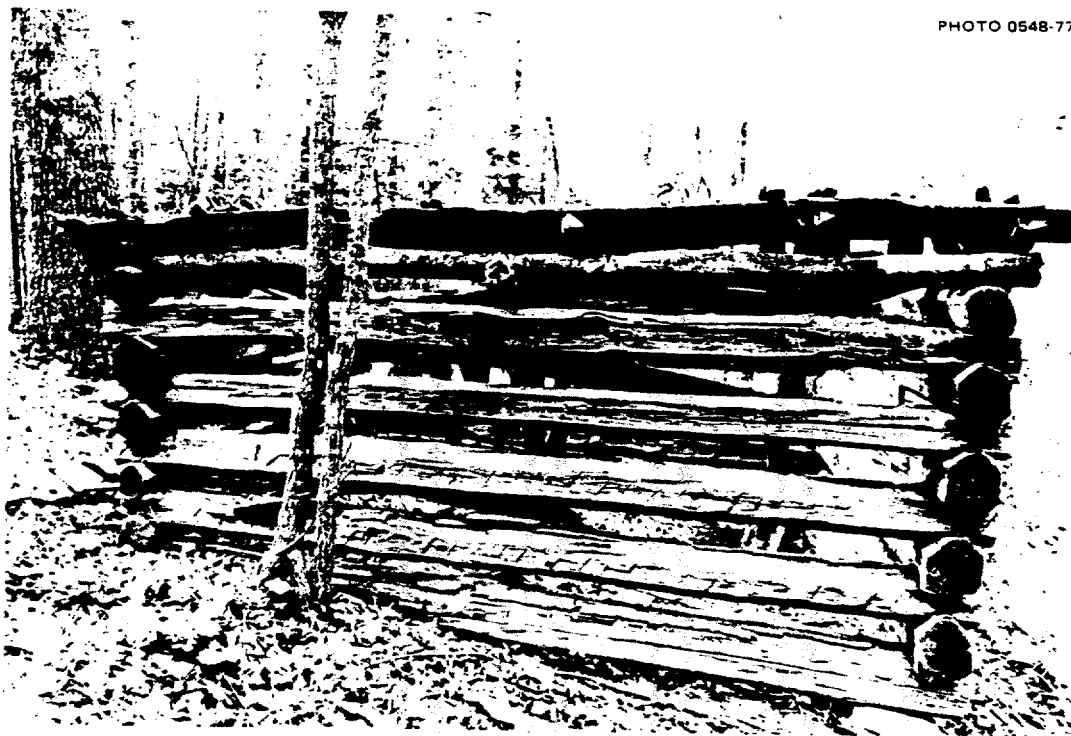
Structure 57A. This structure is a rectangular-log-construction gravehouse built surrounding three grave markers. The fieldstone markers, two headstones and one footstone (two graves), are plain without any inscriptions. The gravehouse was constructed from partially hewn logs joined at the corners with a saddle V-notch (Figs. 13 and 14). It is in good condition and only the roof has collapsed. The cemetery associated with this structure is designated No. 14.

Fig. 13. Structure 57A, Log Construction Grave House Surrounding Two Graves.

Fig. 14. Side View of Structure 57A.

It is highly recommended that the structure be restored by replacing the roof and that it be maintained in a good state of repair as part of the routine cemetery maintenance. This unusual building warrants preservation due to the very small number of log gravehouses remaining in Tennessee.

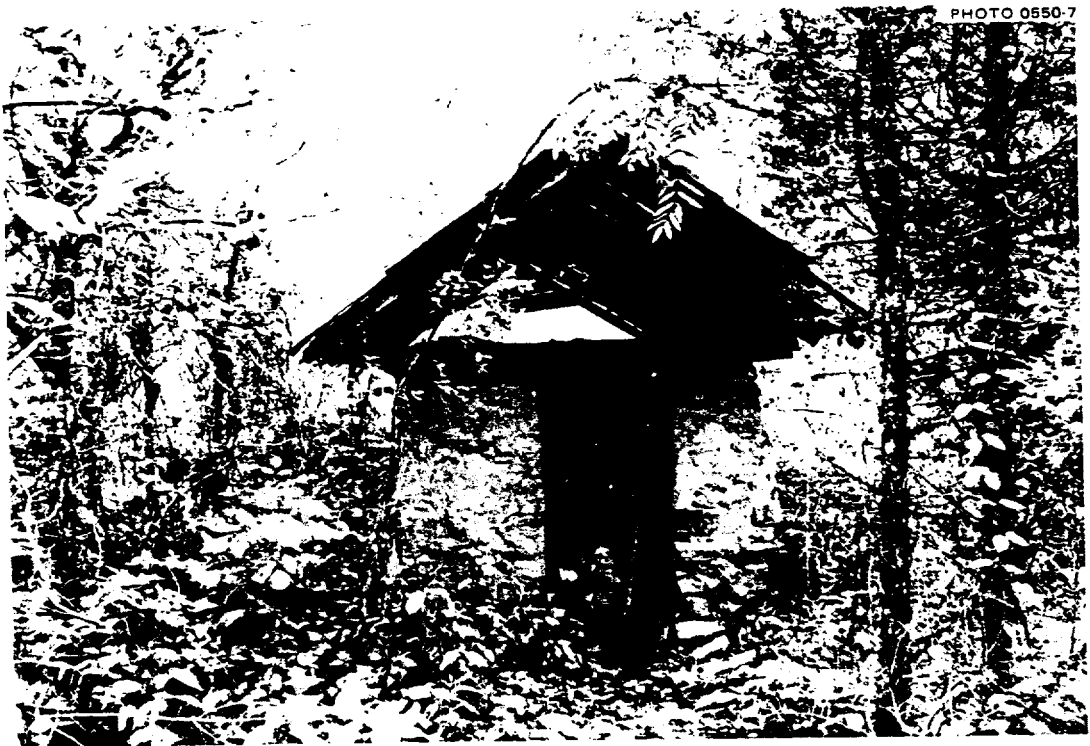
Structure 753A. This was the only stone building encountered during the survey. Built using fieldstone bonded with cement mortar, it has a rectangular plan and a gabled roof (Fig. 16). The field party

Fig. 16. Field Stone Construction Building, Structure 753A.

did not determine the function of this structure. Measured drawings and detailed photographs should be prepared of this building if it is threatened with destruction.

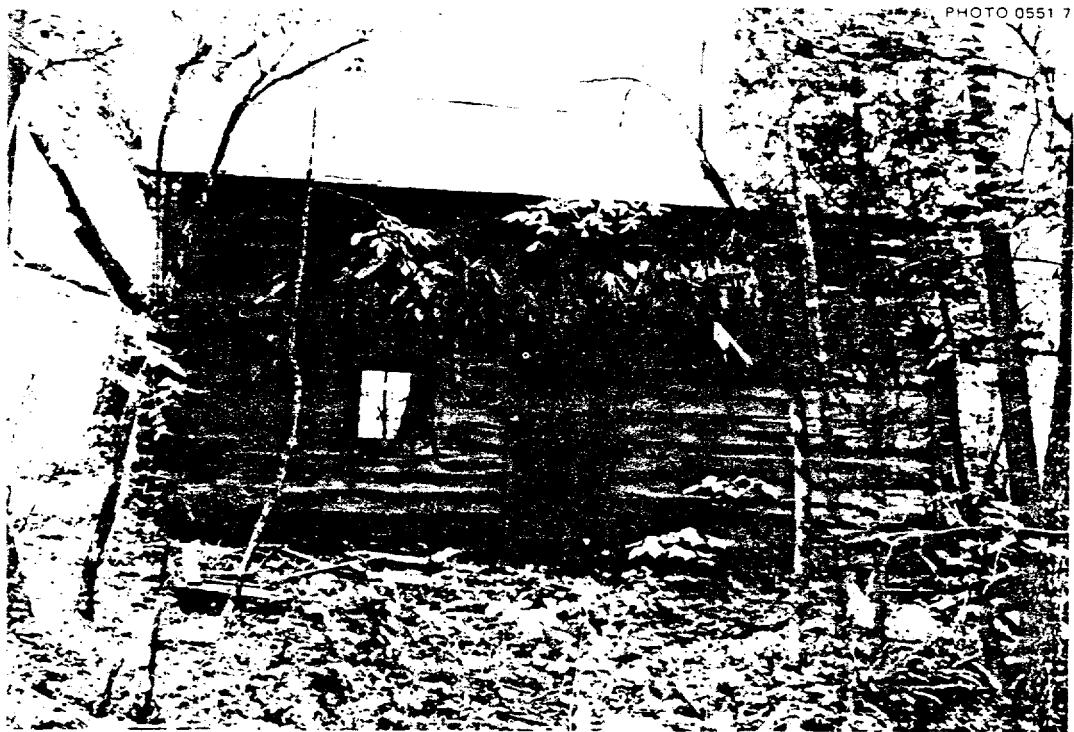
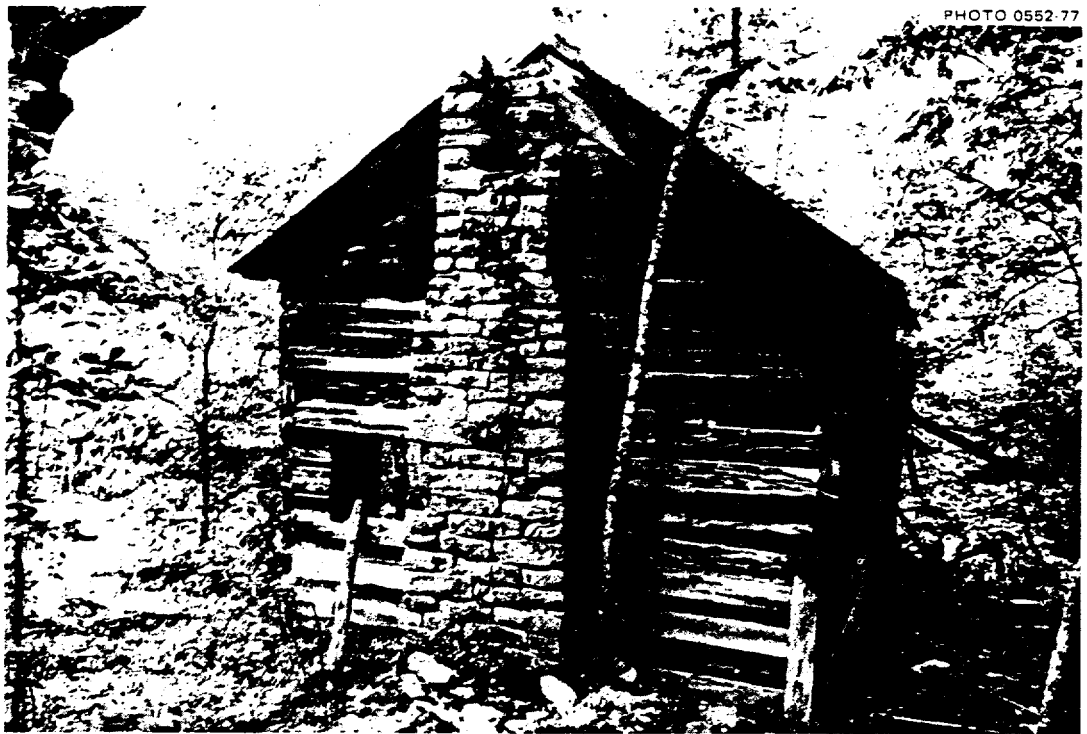
Structure 853A. Excluding the Freels Cabin, the best example of log architecture recorded by the survey party is Structure 853A, a single-pen rectangular-plan house with one external limestone block chimney (Figs. 17 and 18). The date of construction has not been determined from documentary sources; but based on the construction methods, size and location of windows, and type of chimney construction, it was possibly built in the first half of the nineteenth century. One end of the structure has been removed to accommodate a frame addition. The structure should be maintained in its present condition until historical research can establish a factual date of construction.

Fig. 17. Front Elevation, Structure 853A.

Fig. 18. Chimney Detail, Structure 853A.

2. The structures currently used for housing UT-CARL personnel should be maintained in their present condition and use.
3. The date of construction of Structure 853A, a log house with limestone chimney, should be determined through historical research. The type of construction and other structural details indicate the house was possibly built in the mid-nineteenth century or before.
